Embankments Stability of an Opencast Mine with the Proposal of a New Mining Method For its Reopening (Kef Essennoun, Algeria)

The main purpose of our study is to treat the stability problem of the phosphate Kef Essennoun quarry in the mining field of Jebel Onk located in the Northeastern part of Algeria.

Keywords: Kef Essennoun, open pit mine, safety factor, embankments stability, mine reopening

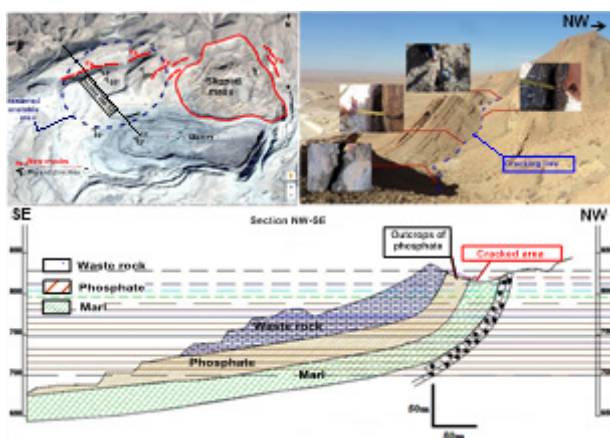
Fig. 2. Location of new cracks on the NW edge of the Kef Essenoun quarry

wards the South, West and Northwest of the deposit. This solution, which seems suitable for the continued extraction of the ore, was hampered by the appearance, in 2013, of new cracks at the top of the Northwest edge of the new exploitation pit. These cracks are located at the phosphate/marl interface (Fig. 2).

advancement of the mining front of the phosphate stands on the west side of the mine (Fig. 2).

For the case of Kef Essennoun quarry, the selection of the profile location adopted for the modeling of the unstable area was made taking into account the location and direction of the cracking line, the probable direction of the slip (from the northwest to the southeast) (Fig. 2, 4).

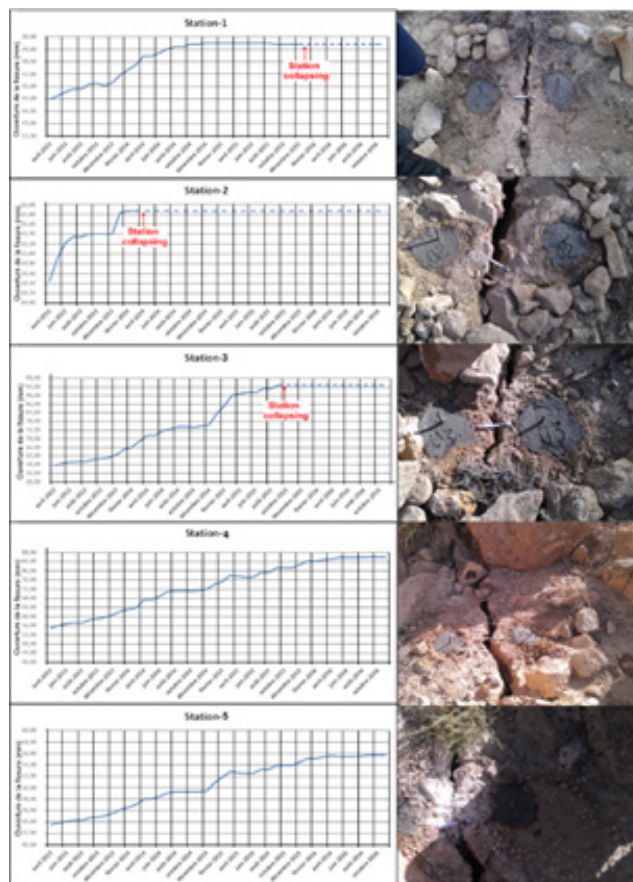
Fig. 3. Control stations from N°01 to 05 with the registration

Control stations. This device, installed along cracking line, is used to monitor the cracks progress in terms of spacing. These are steel stakes concreted in two points located on either side of a crack in which, periodic and continuous linear measurements are made of the distance between the two stakes, this method is widely used because of their low cost and ease of implementation. The measurements taken at these stations, between April 2013 and October 2016, showed that:

- The cracks diverge with a maximum speed of 14 cm/yr, recorded at the station number three (ST-3). Therefore, this area is unstable (Fig. 3);
- The progression of the cracking line follows the

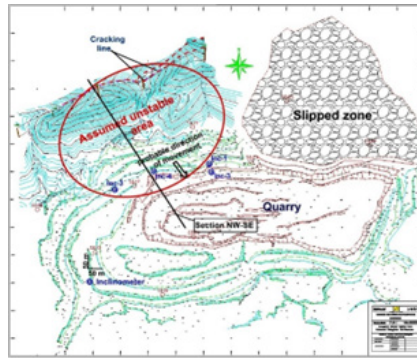
Fig. 4. Characteristics of the supposedly unstable area
Rys. 4. Charakterystyka rzekomo niestabilnego obszaru

Figure 4 shows a survey plan of the Kef Essennoun phosphate mine, updated in January 2016. The unstable zone is

located in the Northwestern part of the new exploitation pit and extends over a surface area of more than 20 hectares with a total volume exceeding 10 million cubic meters, which risks being in motion.

This area is bounded at the bottom by the operating benches (free surface), at the top by the cracking line and to the left and right by a few talwegs. Therefore, the only probable direction of the slide is from the North-West to the South-East (towards the feet of the benches).

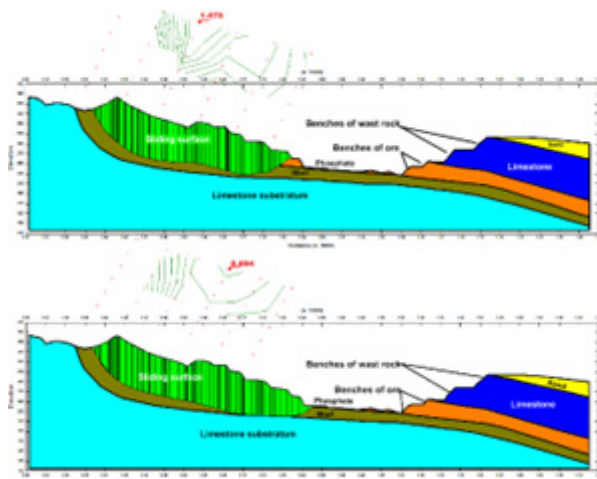
Fig. 6. Sliding surface (hatched in green) for the minimal factor of safety for both approaches: A) without the blasting effects; B) with the blasting effects
Rys. 6. Powierzchnia ślizgowa (zakreskowana na zielono) dla minimalnego współczynnika bezpieczeństwa dla obu podejść: A) bez efektów wybuchowych; B) z efektami wybuchowymi

According to the results obtained by the numerical modeling (Tab. 4 and Fig. 6), one notes that:

Approach-1: All security factors calculated by the different methods are greater than the minimum tolerated threshold for the slope stability ($FS > 1$), with a minimum safety factor of 1.312, obtained by the Janbu method. Thus, the edge is stable.

Approach-2: All safety factors are critical ($FS \leq 1$), with a minimum safety factor of 0.806, also obtained by the Janbu method. Thus, the edge is unstable.

The sliding surfaces given by these two approaches have a non-circular (polygonal) shape and located in the marly layer, with a slight difference in the volume of the unstable rock mass (Fig. 6) between the two approaches.

blasting effects. The obtained results are illustrated in the table 4 and figure 6.

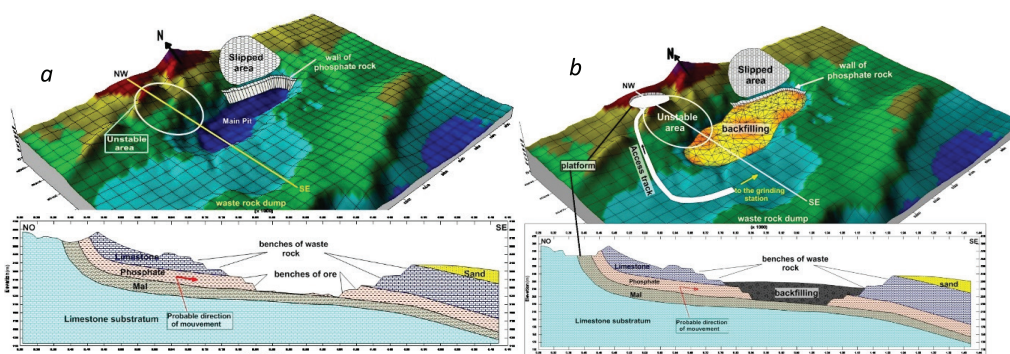
Fig. 7. Current situation of the phosphate quarry (a) and Condition of the quarry after backfilling and reopening of the initial platform (b)

by a wall of phosphate rock (security barrier). In the North-western side, we find the unstable zone and to the south the waste rock dump (Fig. 7-a).

Access track and working platform. After the backfilling work of the main exploitation pit, we will reopen the deposit by creating of another access track to the upper levels and reopening a new working platform in the outcrop of the phosphates layer (Fig. 7-b).

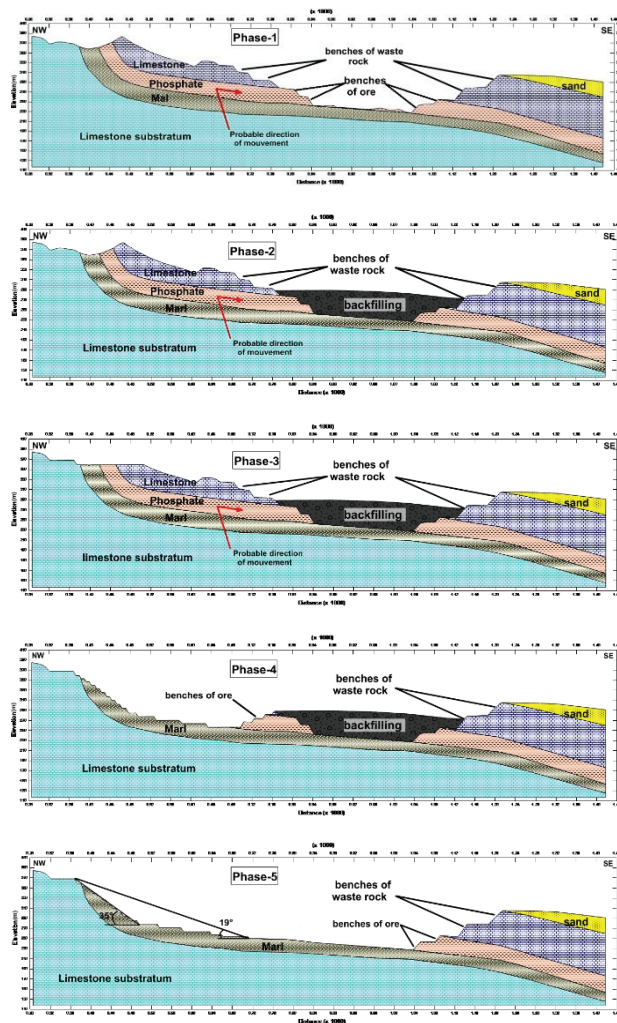
Fig. 8. Development stages of the mining exploitation of Kef Essennoun deposit
Rys. 8. Etapy rozwoju eksploatacji górniczej złoża Kef Essennoun

- The reopening of an initial platform and the elimination of the overlying waste rock (hill), in order to reduce the load above the unstable zone (Fig. 10, 11; Phase 3).
- The continuation of the mining exploitation from the top to the bottom, level by level, in the dip direction of the phosphate layer, with bleachers not exceeding 12 m in height and an inclination β of 70° . Regarding the security and cleaning berms (bs, bn) we take a minimum width of 8 m, these parameters give us a maximum ultimate edge which does not exceed 35° (Fig. 8, Phase 4, 5).

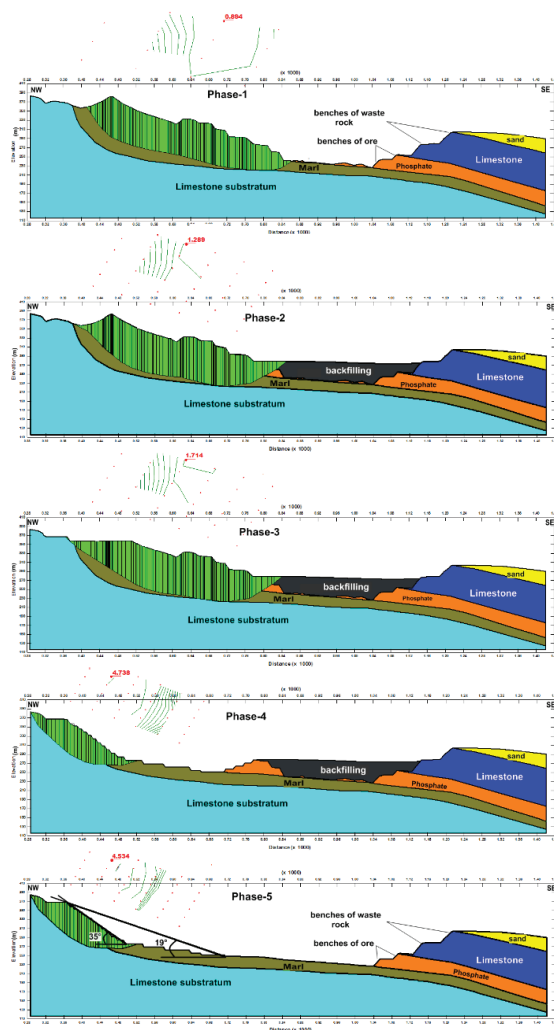
Fig. 9. Sliding surfaces for the minimum safety factor for the development phases of the Kef Essennoun quarry
 Rys. 9. Powierzchnie ślizgowe dla minimalnego współczynnika bezpieczeństwa dla faz rozwoju kamieniołomu Kef Essennoun

From the results of table 6 and figure 9, we notice:

- The remarkable influence of the backfill operation on the stability of the Northwestern side of the Kef Essennoun quarry, where the safety factors were increased at a rate of over 30% after backfilling.
- After the backfilling of the pit, all the safety factors calculated by the different methods are much greater than 1 ($FS > 1$), which means that the edge is stabilized.
- For the different development phases of the deposit (Phase 3, 4 and 5) (Tab. 6), all the safety factors are greater than 1 ($FS > 1$). Therefore, there will be no risk of instability at during mining operations, provided that we comply with the recommended technical and technological parameters ($hg \leq 12$ m, $\beta g \leq 70^\circ$, $bs, bn \geq 8$ m) and under current blasting conditions.

progressed, the results of which are shown in Table 6 and Figure 9.
